SIM800 Series_ Software Upgrade _Application Note_V1.04

Document Title:	SIM800 Series_Software Upgrade_Application Note
Version:	1.04
Date:	2016-11-17
Status:	Release
Document Control ID:	SIM800 Series_Software Upgrade_Application Note_V1.04

This document describes how to use the PC or external MCU to upgrade software of SIM800 series modules by serial port.

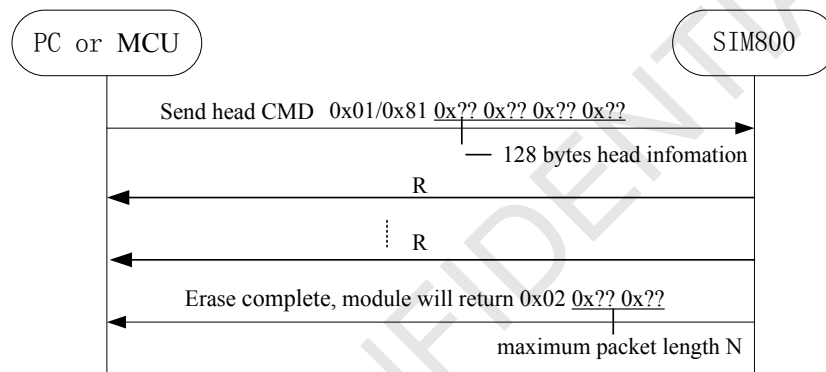
Command word 0x01 means there is no need to erase the file system of the module, while 0x81 means it needs to erase the file system of the module. In the version upgrade, such as upgrading

command	data
0x01/0x81	128 bytes head information

confirm	Maximum data length N
0x02	2 bytes with low in the front and high in the post

Figure 4: Send head information
